Home Inspections

Property Inspection Report

123 Main , Hillsboro, OR 97124

Date of Inspection: 3/7/2019 Time: 4:30

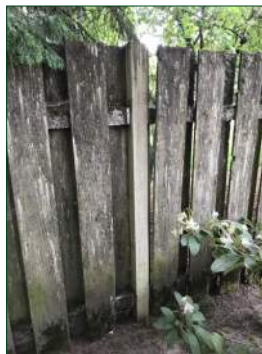
- Fences were made of wood.
- The inspector observed few deficiencies in the condition of the fences. Notable exceptions will be listed in this report.
- Fence had a post that had failed due to decay. The fence was leaning in this area.

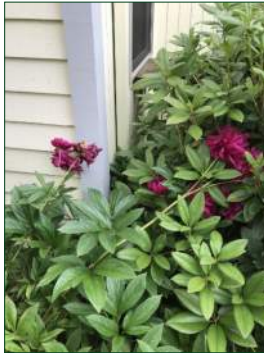
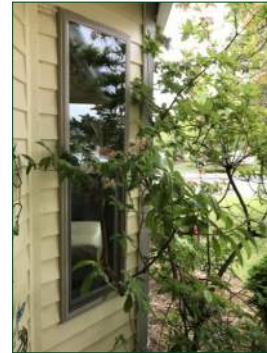
- Vegetation in contact with the exterior walls should be cut back to avoid potential problems from moisture or insects.

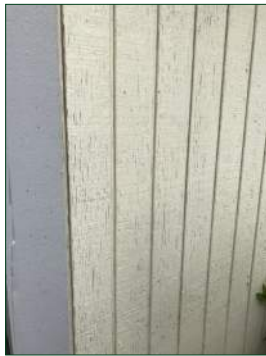
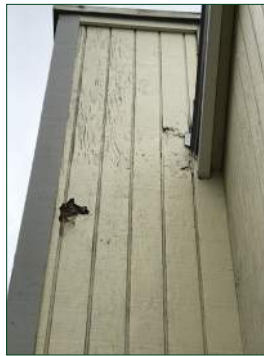
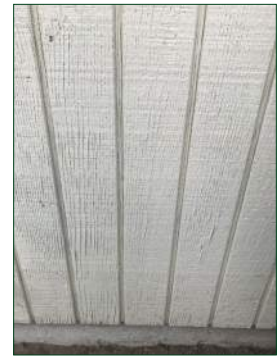
- Wood siding covering the exterior walls of the home exhibited moderate general weathering, and deterioration commensurate with its age.
 - Finish coating designed to protect the wood siding was moderately deteriorated at the time of the inspection. Maintenance performed on an appropriate schedule can significantly extend the lifespan of wood siding exposed to weather. You should ask the seller for information about products and schedules related to and siding maintenance performed in the past.

- Animal damage to wood siding covering exterior walls of the home was visible at the time of the inspection. The damage consisted of chewed, scratched or broken siding typical of attempts by animals such as squirrels or raccoons to gain entry. Scent-based repellants are available from companies specializing in wildlife damage prevention which may discourage this activity. try the following websites:
<http://icwdm.org/ControlMethods/repellents.asp>
<http://www.messinawildlife.com/>

- The Inspector recommends that finish coat maintenance be performed to prevent deterioration and extend the lifespan of wood siding components. All work should be performed by a qualified contractor.

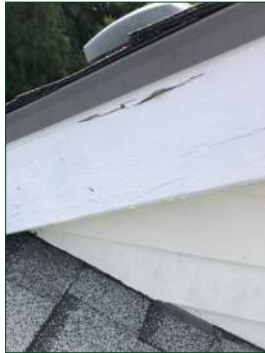
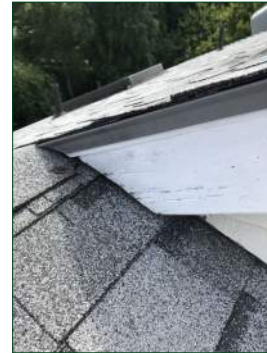
- Trim at the gabled end had peeling paint and needed maintenance to avoid wood damage from weather and sunlight. All work should be performed by a qualified contractor.

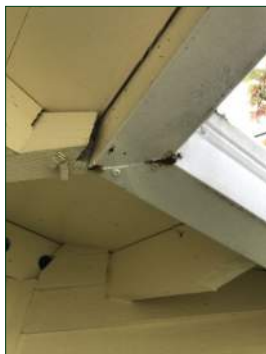
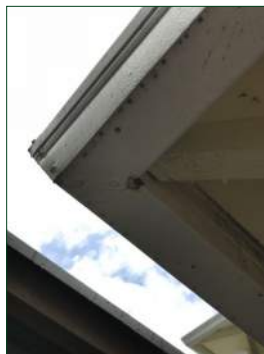
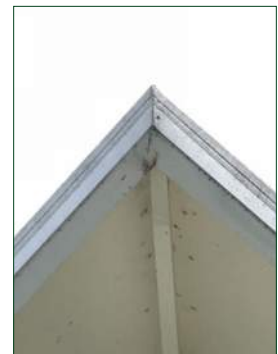
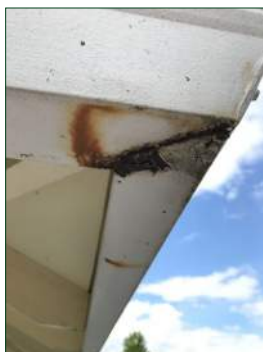
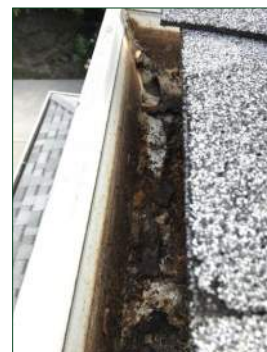
• The gutters were leaking at various areas and needed maintenance such as the application of an appropriate sealant. This condition can result in excessively high moisture levels in soil at the foundation and can cause damage related to soil/foundation movement. Excessive moisture levels in soil near the foundation can effect the ability of the soil to support the weight of the structure above and can cause damage related to soil/foundation movement. The Inspector recommends repair to help protect the home structure. All work should be performed by a qualified contractor.

• Gutters exhibited severe corrosion and may need to be replaced soon. The Inspector recommends that before the expiration of your Inspection Objection Deadline you consult with a qualified contractor to gain an idea of options and costs for replacement.

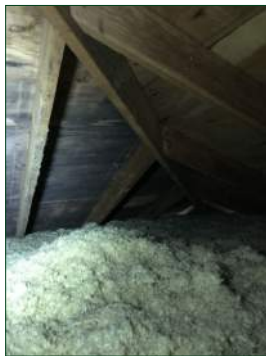
Microbial Growth on Roof Sheathing

- The attic exhibited widespread discoloration that appeared to be microbial growth, possibly mold. Confirming the presence of mold would require laboratory analysis. To avoid potential damage to home materials or the development of unhealthy conditions related to mold, the Inspector recommends that the source of moisture be identified and the condition corrected.

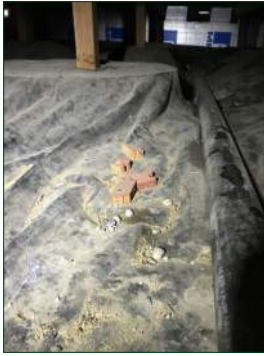
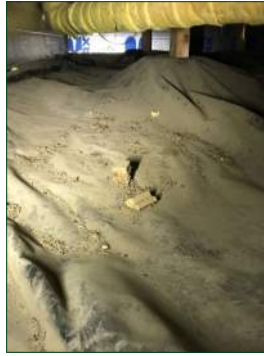
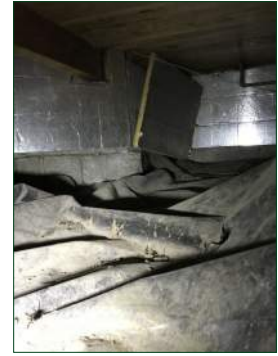
• Debris accumulated in this crawlspace should be removed before the final walk-through.

• Rigid Insulation falling from foundation stem wall. Recommend correction by qualified contractor.

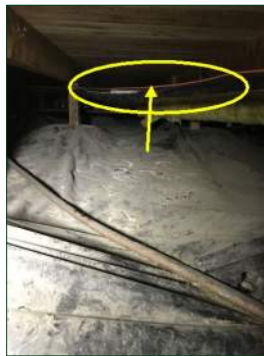
- Poorly supported electrical wires in the crawlspace should have an adequate number of additional supports added by a qualified electrical contractor.

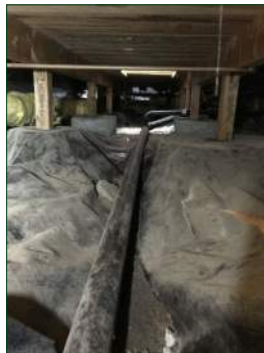
- The inside of the exterior basement walls were insulated with foam board.
- No insulation was installed in the floor of the unheated crawlspace. Insulation here is highly recommended but was not required by code when the home was built.

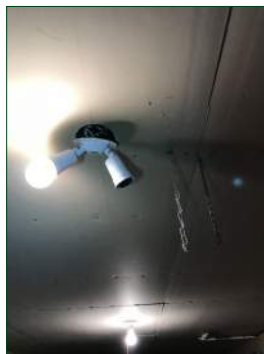
- A light in the garage had energized electrical wires exposed to touch at the time of the inspection. This condition may represent a potential fire or shock/electrocution hazard. The Inspector recommends an examination and any necessary repairs be performed by a qualified electrical contractor.

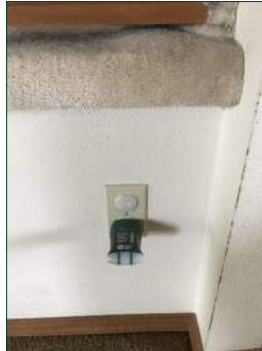
- An electrical receptacle in the was inoperable at the time of the inspection. The Inspector recommends service by a qualified electrical contractor.

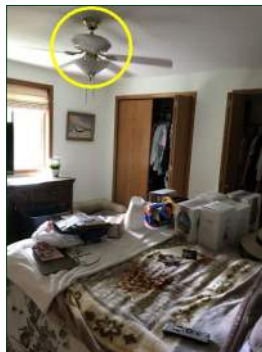
- A ceiling fan installed in the master bedroom was inoperable. The problem may be the switch, wiring in the wall/ceiling, or problems with the ceiling fan. The inspector recommends evaluation and any necessary work be performed by a qualified contractor.

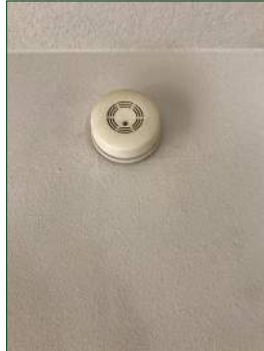
- The home had one smoke detector that was interconnected through the home branch wiring, there were no more hard-wired detectors. You should check the detector indicator lights occasionally to be sure that the detector has power. This detector was over 10 years old and needs to be replaced.

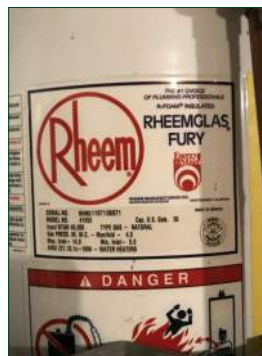
- This water heater appeared to be past its design life and may need replacement soon.

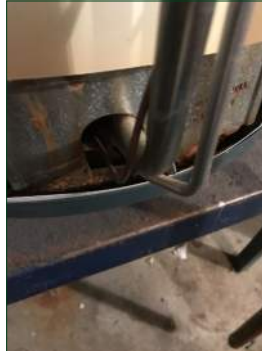
- The water heater burn chamber was clean and in good condition at the time of the inspection.
- The bottom water heater burn chamber exhibited moderate accumulation of metal flakes that are typically the product of corrosion of the water tank. This indicates that the water tank has suffered some corrosion.

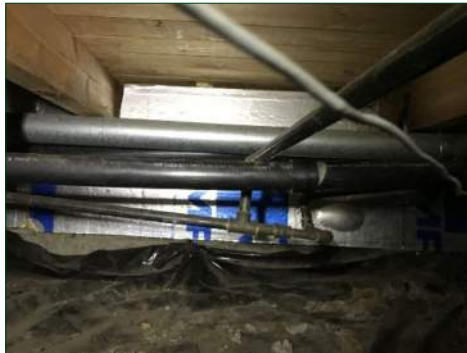
- The home gas distribution pipes were black steel.
- Gas Piping in this location is unsupported and is resting on DWV Piping. I recommend inspection and correction by a qualified plumbing contractor.

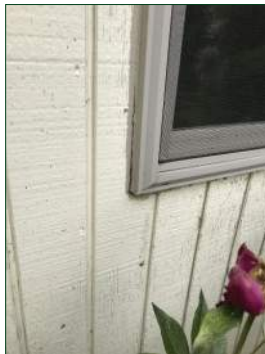
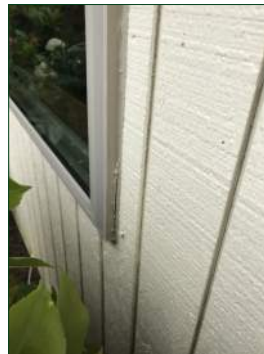
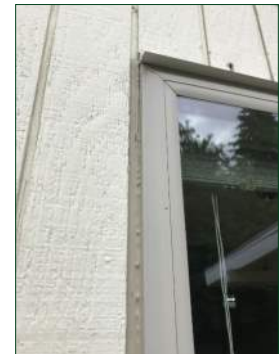
- The Inspector observed few deficiencies in the interior condition and operation of windows of the home. Notable exceptions will be listed in this report.
- Exterior Window Caulking showed signs of cracking and deterioration. This is a maintenance item that these windows will require yearly.

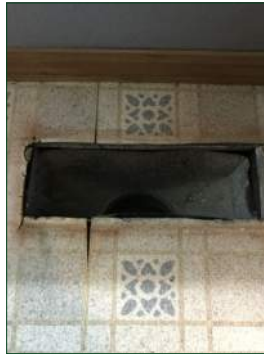
- At the time of the inspection, the Inspector observed no deficiencies in the condition of floors in the laundry Room.
- The laundry room had moderate vinyl floor damage visible at the time of the inspection. Before the expiration of your Inspection Objection Deadline you may wish to consult with a qualified contractor to discuss options and costs for repair.

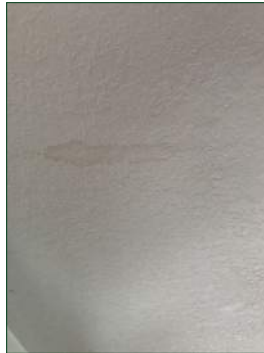
- The bedroom ceiling appeared to be in serviceable condition at the time of the inspection.
- Stains on the ceiling in this bedroom appeared to be the result of moisture intrusion from roof leaks. The moisture meter showed no elevated levels of moisture present in the affected areas at the time of the inspection, indicating that the source of moisture may have been corrected. You should ask the seller about this condition.

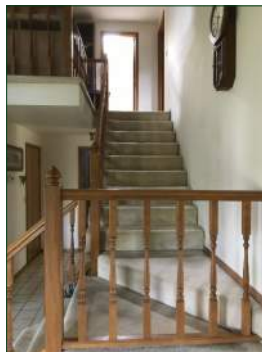
- A horizontal guardrail assembly protecting this stairwell had spaces between handrail components that allowed the passage of a 4-inch sphere. To improve child safety, the Inspector recommends altering the guardrail assembly in a manner which will prevent the passage of a 4-inch sphere. This dimension includes areas beneath and to the sides of the guardrail. The Inspector recommends that this condition be updated to meet generally-accepted modern safety standards by a qualified contractor.

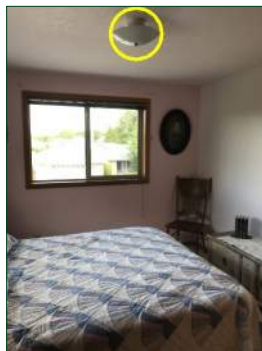
- A light fixture in this bedroom did not respond to the switch. The bulb may need to be replaced or there may be a problem with the switch, wiring or light fixture. If after the bulb is replaced this light still fails to respond to the switch, this condition may represent a potential fire hazard and the Inspector recommends that an evaluation and any necessary repairs be performed by a qualified electrical contractor.

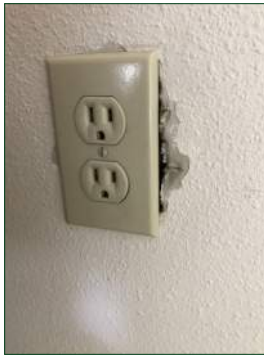
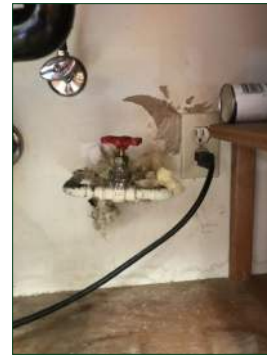
- Minor amounts of rodent feces was visible at various areas of the home. Traps should be set for mice and avenues of entry located and blocked.
- Signs of animal chewing were visible in the . Chewing of electrical wiring is a potential fire hazard. After ensuring that no animals remain, all avenues of entry should be blocked.

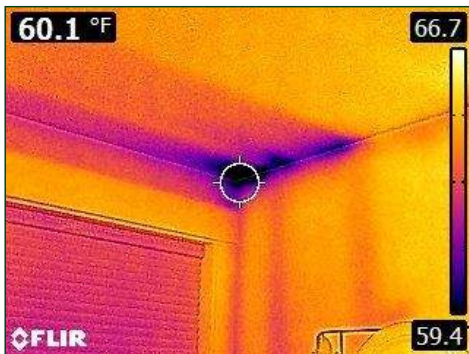
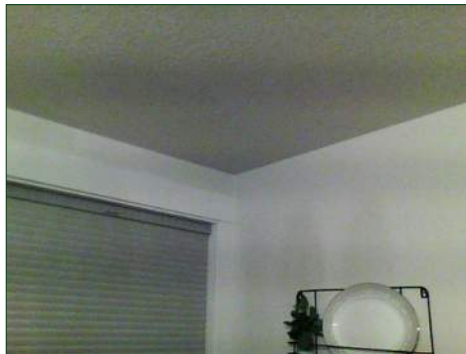
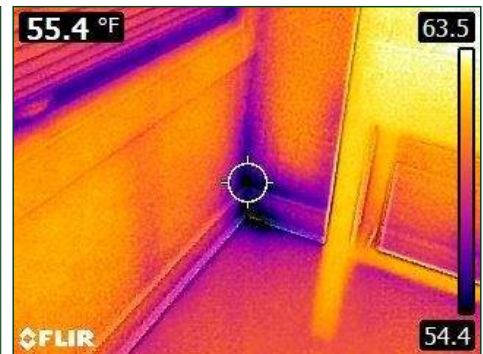
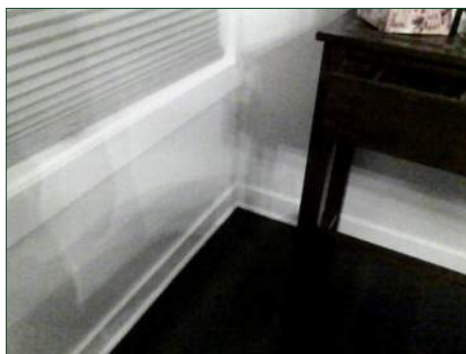
- Thermal imaging indicated excessively high moisture levels in wall materials in the dining room. The source of moisture appeared to be poorly-installed exterior wall-covering materials. The inspector recommends that before the expiration of your Inspection Objection Deadline an inspection be performed by a qualified contractor to confirm and correct the source of moisture.
