Home Inspections

Property Inspection Report

123 Main , Hillsboro, OR 97124

Date of Inspection: 3/7/2019 Time: 4:30

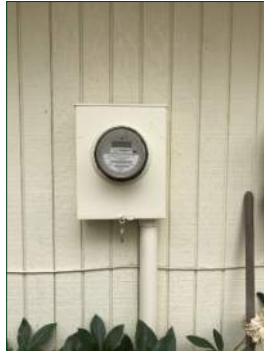
- The electric meter was located at the left side of the home.

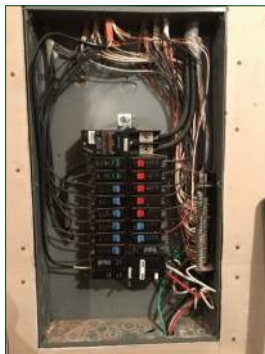
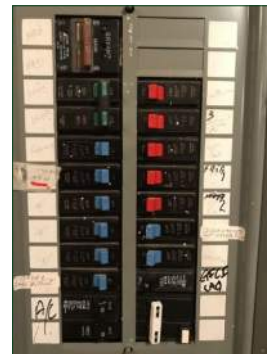
- The Inspector observed no deficiencies at the electrical service panel at the time of the inspection. Inspection of the main service panel typically includes examination of the following:

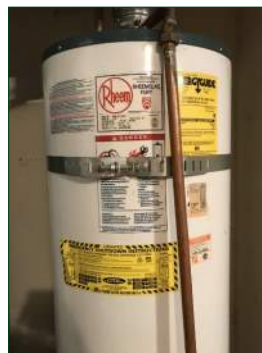
- At the time of the inspection, the Inspector observed no deficiencies in the condition or operation of the water heater.

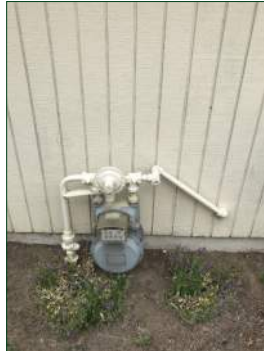
- The main gas shut-off was located at the gas meter located at the left side of the home.

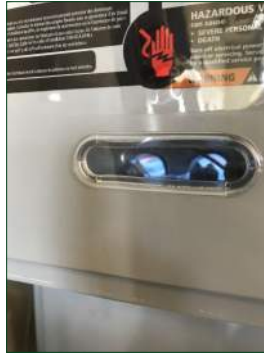
- Conditions in the furnace combustion chamber appeared to be acceptable at the time of the inspection. Some of the combustion chamber was not visible. A full evaluation of the combustion chamber would require the services of a qualified heating, ventilation and air-conditioning (HVAC) contractor.

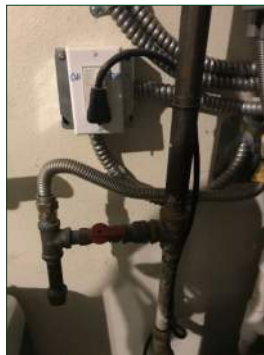
- The furnace electrical and gas shut-offs are shown in the photo.

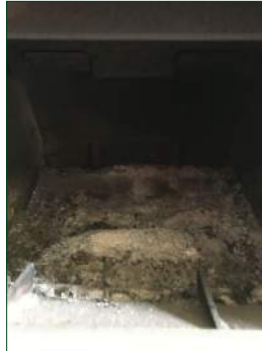
- At the time of the inspection, the Inspector observed no deficiencies in the condition of the Wood-Burning Insert in the main floor family room. Full inspection of Wood-Burning Insert fireplaces lies beyond the scope of the General Home Inspection. For a full inspection to more accurately determine the condition of the fireplace and to ensure that safe conditions exist, the Inspector recommends that you have the fireplace inspected by an inspector certified by the Chimney Safety Institute of America (CSIA). Find a CSIA-certified inspector near you at <http://www.csia.org/search>

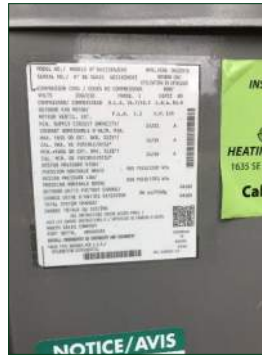
- Information from the air-conditioner label/data plate is shown in the photo.
- The air-conditioner date of manufacture appeared to be 2016.
